400'89 Ascend Aeon

- User Manual

Version 01

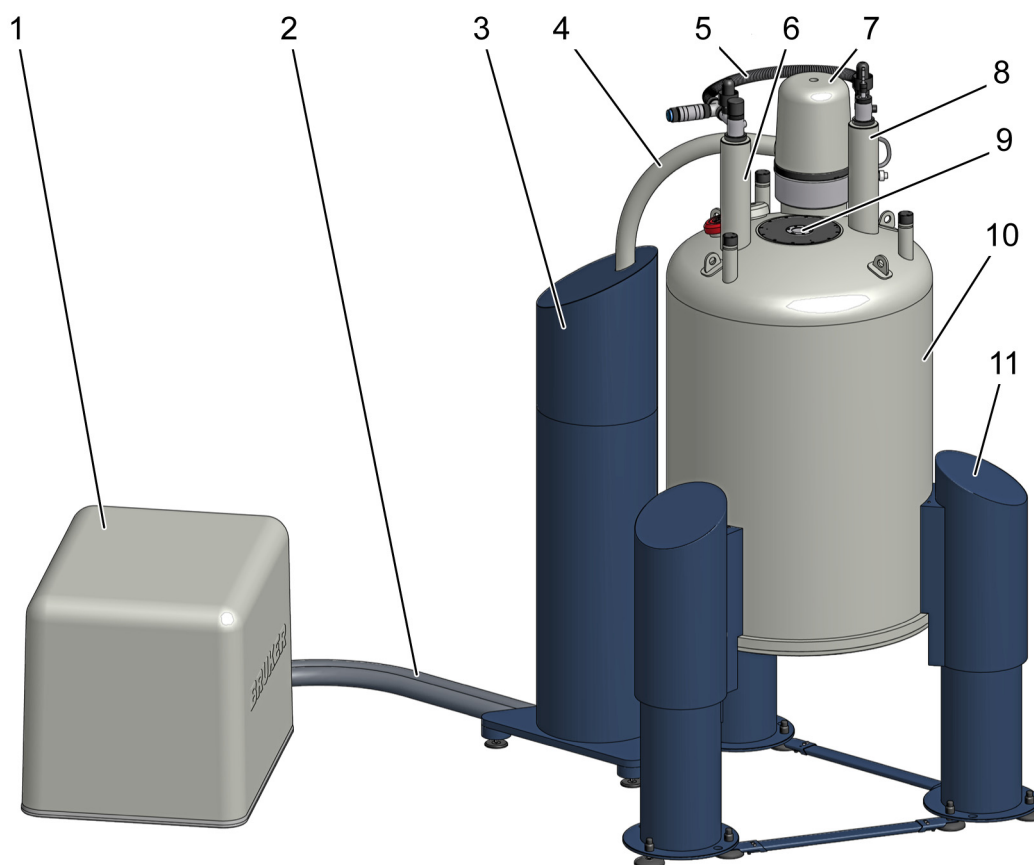
1.6 General View

| 1 Cryogenic Refrigerator Compressor

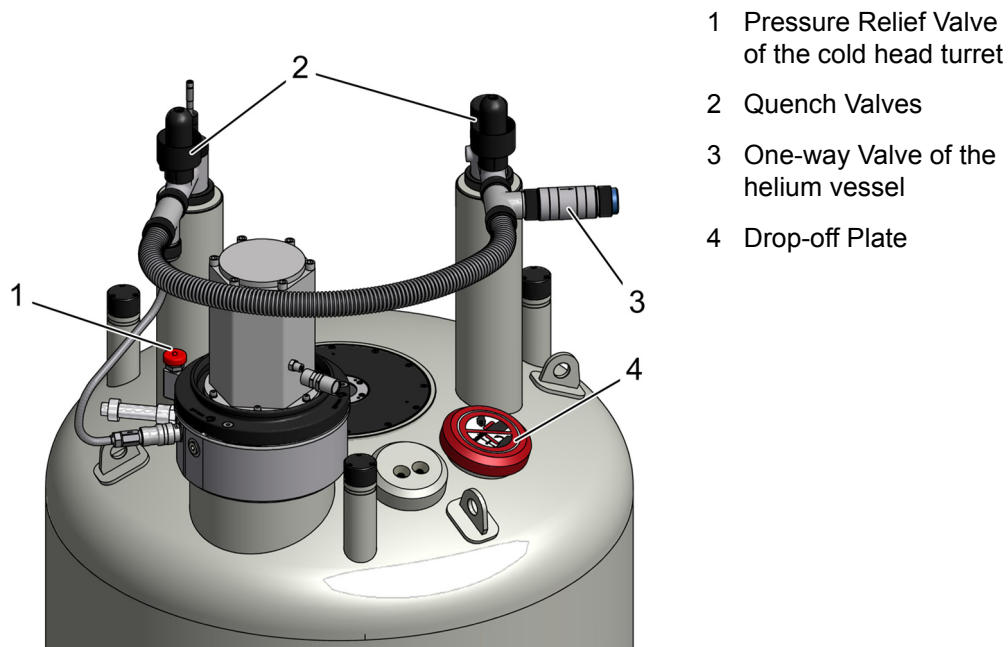
Figure 2.1: Safety devices of the cryostat

The supplied cryostat of the magnet system is equipped with the following safety devices:

Pressure Relief Valve

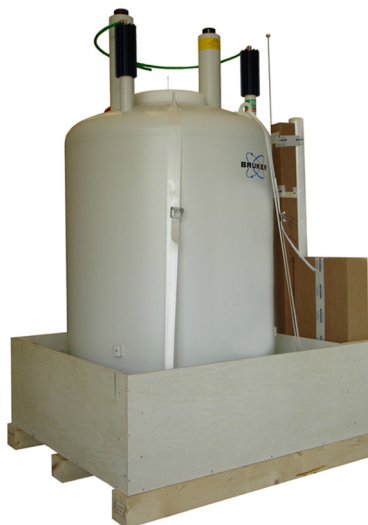
The cryostat is supplied in a wooden box on a pallet. It is secured inside with straps against tilting and moving.

Accessories such as the flow systems, level sensors and bore tubes are in the side compartment of the box.

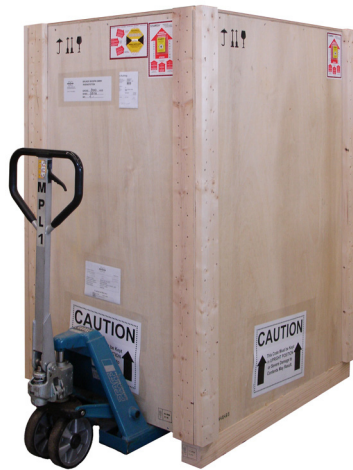
Figure 3.2: Transportation by forklift - front side

1. Check the route of transport for the minimal height and width.
2. Check sufficient floor capacity on the route of transport. In case of doubt ask a stress analyst.
3. Check sufficient carrying capacity while using an elevator.
4. Position the forks between the bars of the box as shown in the figure. Make sure the side towards the operator is the one with the labels on it.

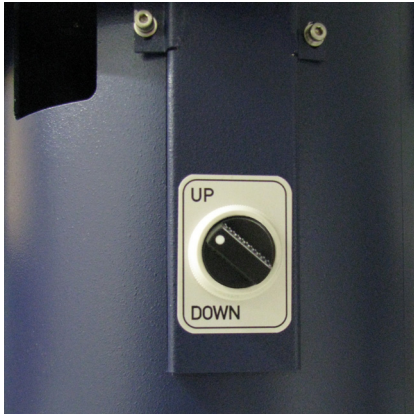
Figure 5.1: Start the Magnet Stand

Set the magnet stand into operation by switching the pneumatic controller to UP position.

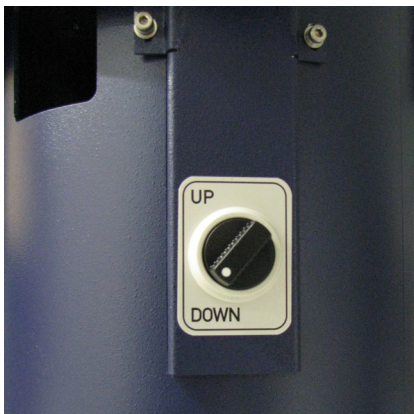
Figure 5.2: Stop the Magnet Stand

For any work at the magnet system like maintenance or refill of helium stop the magnet stand by switching the pneumatic controller to DOWN position.

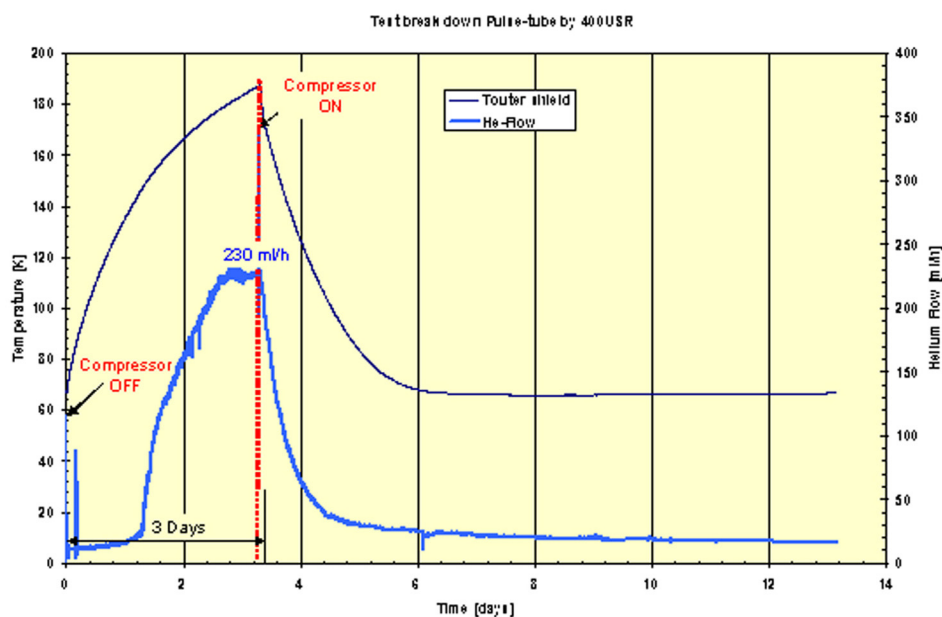
Figure 6.2: Temperature profile during Cryogenic Refrigerator failure

If restarting the Cryogenic Refrigerator was successful, it will take at least two days to recover the previous state of the magnet system.

- If the temperature and helium boil off does not decrease within two following days call Bruker Service.
