500'89 Ascend Aeon

● User Manual

Version 00

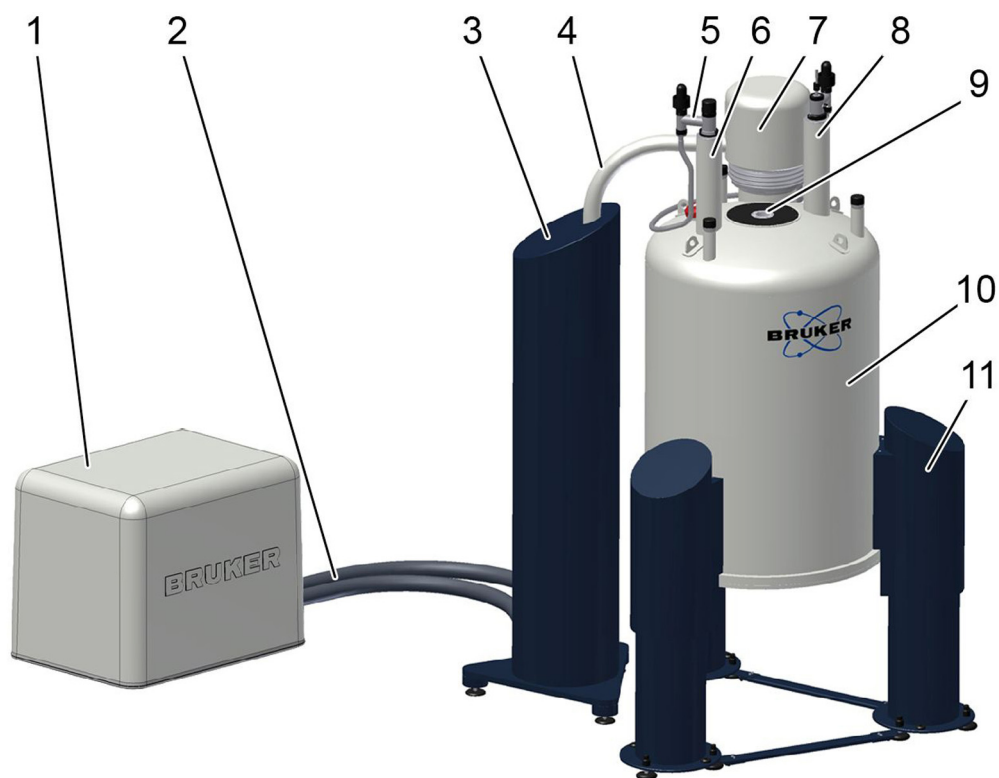
1.6 General View

- 1 Cryogenic Refrigerator Compressor
(noise protection cover optionally)
- 2 Cryogenic Refrigerator Flex Lines
- 3 Rotary Valve (RV) covered by the
Rotary Valve Column (RVC)
- 4 Connecting Line
- 5 Helium Flow System
- 6 Current lead turret
- 7 Cryogenic Refrigerator Cold Head
- 8 Helium Fill-in Turret with helium fill-in port
- 9 RT bore
- 10 RT vessel
- 11 Magnet Stand

Figure 1.1:	General view a Magnet System with Aeon /RZ Cryostat	12
Figure 2.1:	Safety Devices of the RZ Cryostat.....	28
Figure 3.1:	Packaging (without surrounding panels).....	31
Figure 3.2:	Transportation by forklift - front side	33
Figure 3.3:	Transportation by forklift - rear side	33
Figure 3.4:	Attachment points for lifting equipment.....	34
Figure 3.5:	Instruction label for lifting equipment	34
Figure 5.1:	Start the Magnet Stand	40
Figure 5.2:	Stop the Magnet Stand	40
Figure 6.1:	Quench picture.....	78
Figure 6.2:	Temperature profile during Cryogenic Refrigerator failure.....	81
Figure A.1:	Dimension Cryostat - Front View	100
Figure A.2:	Dimension Cryostat - Top View	102
Figure A.3:	Helium Level Graph	104
Figure A.4:	Helium Level Sensor	105
Figure A.5:	Characteristic Curve PT 100.....	106
Figure A.6:	Characteristic Curve IBT	107
Figure A.7:	Wiring Diagramm Temperature Sensors	108
Figure A.8:	Fringe field plot	110

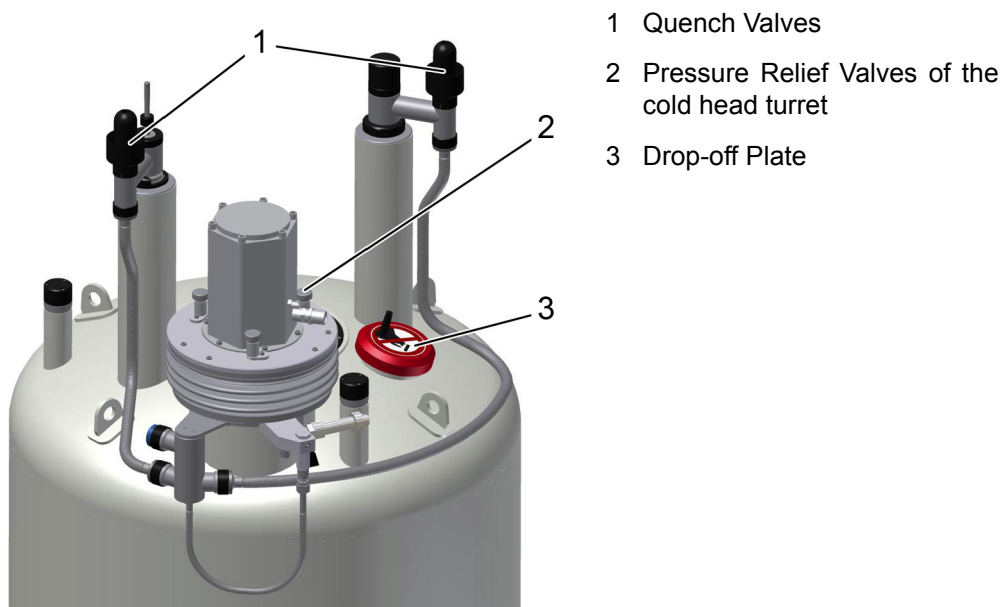
Figure 2.1: Safety Devices of the RZ Cryostat

The supplied cryostat of the magnet system is equipped with the following safety devices:

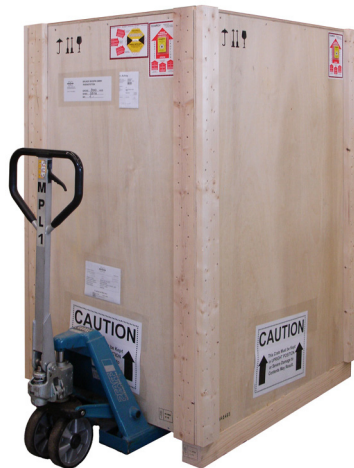
Figure 3.2: Transportation by forklift - front side

1. Check the route of transport for the minimal height and width.
2. Check sufficient floor capacity on the route of transport. In case of doubt ask a stress analyst.
3. Check sufficient carrying capacity while using an elevator.
4. Position the forks between the bars of the box as shown in the figure. Make sure the side towards the operator is the one with the labels on it.

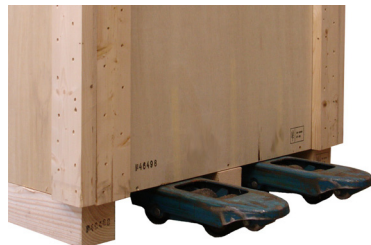
Figure 3.3: Transportation by forklift - rear side

5. Make sure the forks of the fork lift are longer than the box and projects out of the back of the box as shown in the figure.
6. Now lift the fork and move the box to the site.

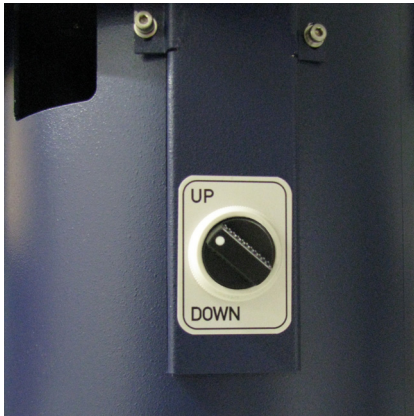
Figure 5.1: Start the Magnet Stand

Set the magnet stand into operation by switching the pneumatic controller to UP position.

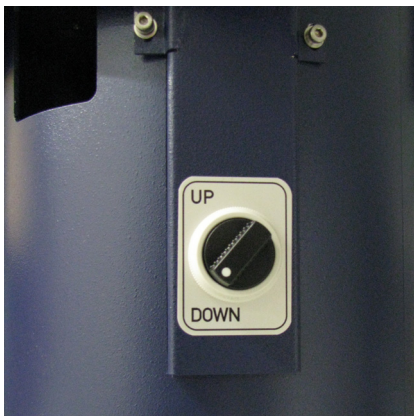
Figure 5.2: Stop the Magnet Stand

For any work at the magnet system like maintenance or refill of helium stop the magnet stand by switching the pneumatic controller to DOWN position.

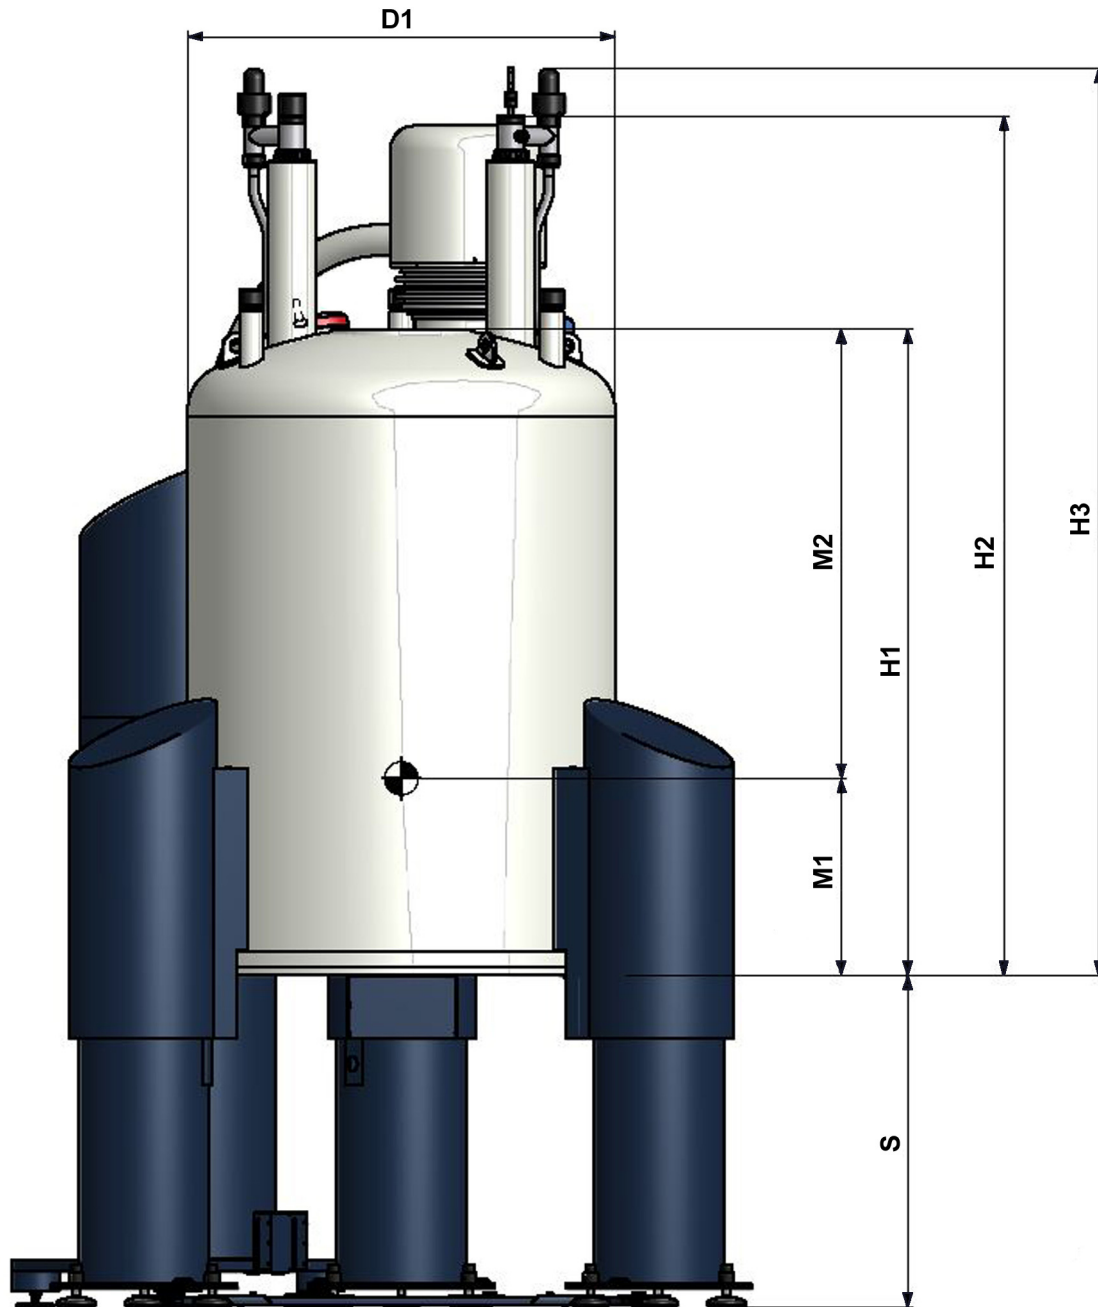
Figure A.1: Dimension Cryostat - Front View

Dimensions Cryostat	Value	Unit
C Operational Ceiling Height	2660	mm
D-RT Diameter RT Bore Tube	89	mm
D1 Diameter RT vessel	900	mm
D2 Diameter Bottom Plate	950	mm
H1 Height Cryostat (bottom plate to top flange)	1360	mm
H2 Height Cryostat (minimum height for transportation)	1809	mm
H3 Height Cryostat (bottom plate to flow system)	1908	mm
H4 Height Rotary Valve Column	1800	mm
S Height Magnet Stand (floor to bottom plate)	700	mm
M1 Distance magnetic Center to bottom flange (calculated)	refer to Table A.13, page 119	
M2 Distance magnetic center to top flange (calculated)	refer to Table A.13, page 119

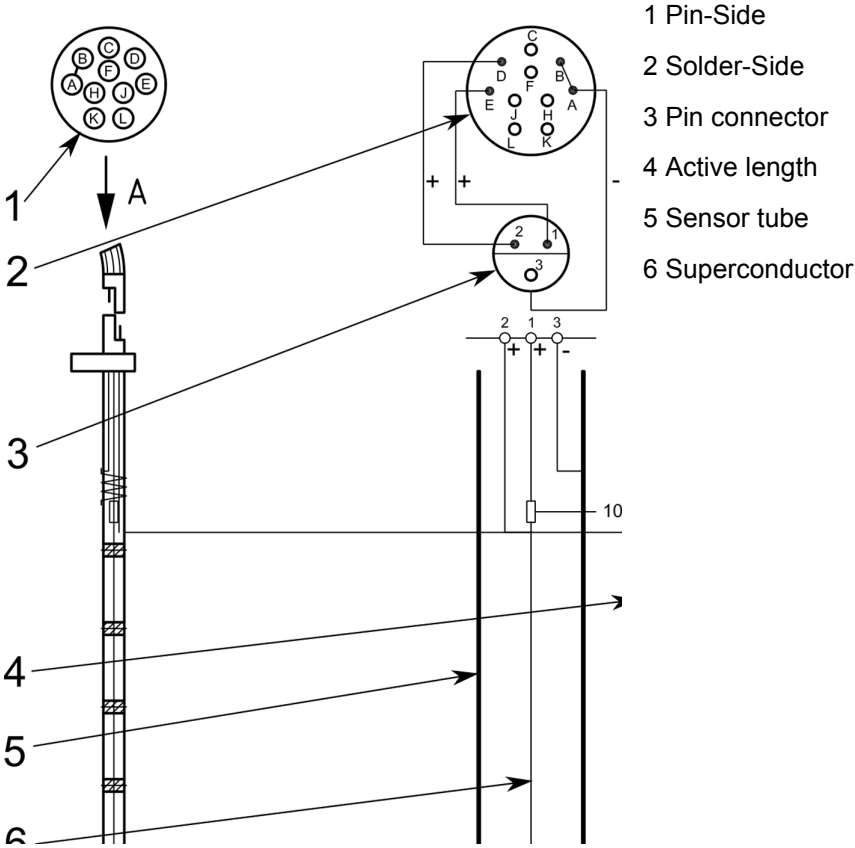
Figure A.4: Helium Level Sensor

Helium Level Sensor	Material No.	Value	Unit
Level Sensor Type	Z58114	1300/690	
Overall length		1300	mm
Active length		690	mm
Calibration 0 %, Calibration resistor	Z28630 blue	140	Ω
Calibration 100 %, Calibration resistor	Z28628 black	15	Ω
