600'54 Ascend Aeon

- User Manual

Version 02

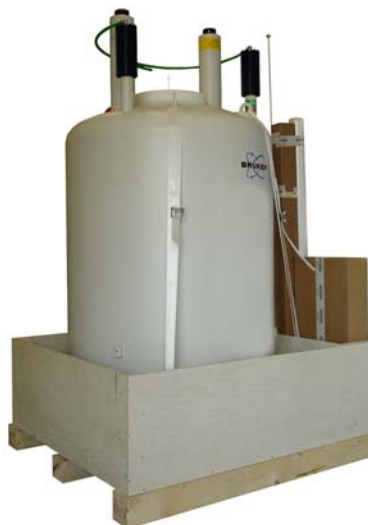
The cryostat is supplied in a wooden box on a pallet. It is secured inside with straps against tilting and moving.

Accessories such as the flow systems, level sensors and bore tubes are in the side compartment of the box.

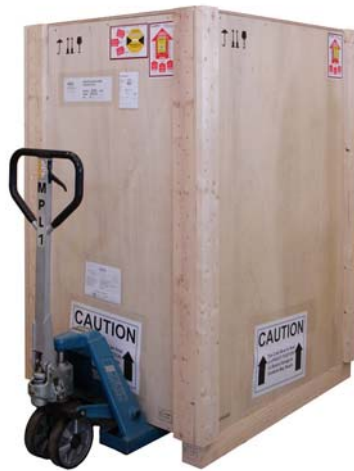
Figure 3.2: Transportation by forklift - front side

1. Check the route of transport for the minimal height and width.
2. Check sufficient floor capacity on the route of transport. In case of doubt ask a stress analyst.
3. Check sufficient carrying capacity while using an elevator.
4. Position the forks between the bars of the box as shown in the figure. Make sure the side towards the operator is the one with the labels on it.

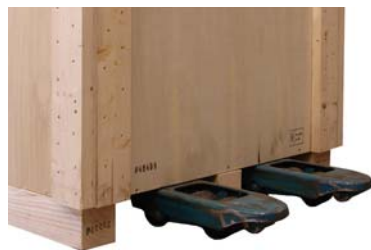
Figure 3.3: Transportation by forklift - rear side

5. Make sure the forks of the fork lift are longer than the box and project out of the back of the box as shown in the figure.
6. Now lift the fork and move the box to the site.

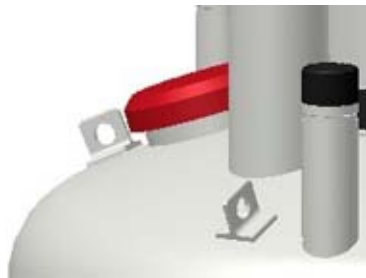
Figure 3.4: Attachment points for lifting equipment

1. Exclusively use the marked eyelets as attachment points for the lifting equipment.
2. Use all eyelets for the lifting equipment.

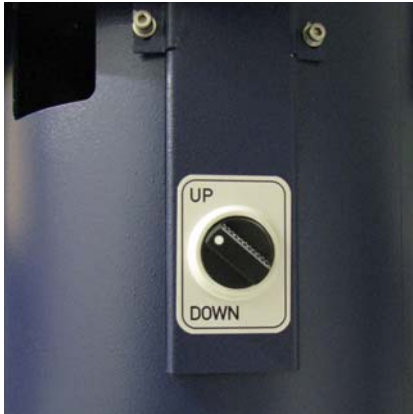
Figure 5.1: Start the Magnet Stand

Set the magnet stand into operation by switching the pneumatic controller to UP position.

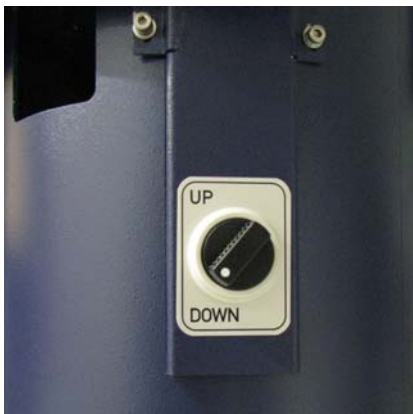
Figure 5.2: Stop the Magnet Stand

For any work at the magnet system like maintenance or refill of helium stop the magnet stand by switching the pneumatic controller to DOWN position.

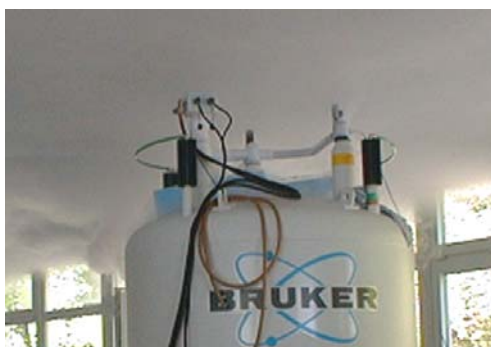
Figure 6.1: Magnet system during a quench

A quench is the very fast de-energizing of the magnet by loss of its superconductivity. The stored magnetic energy is converted into heat, which promotes rapid evaporation of large quantities of helium. If a quench occurs contact Bruker Service immediately.
