700'54 Ascend Aeon

● User Manual

Version 00

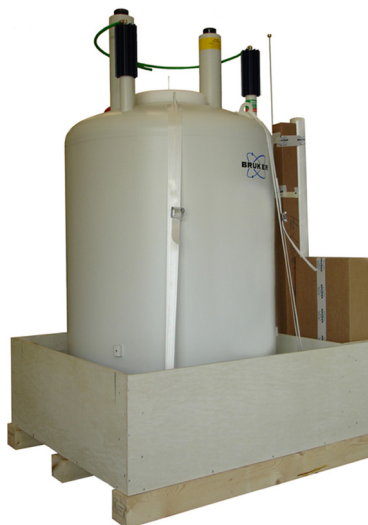
The cryostat is supplied in a wooden box on a pallet. It is secured inside with straps against tilting and moving.

Accessories such as the flow systems, level sensors and bore tubes are in the side compartment of the box.

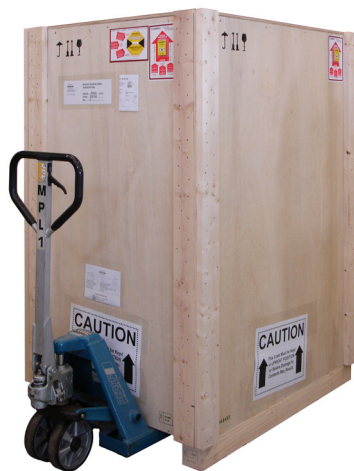
Figure 3.2: Transportation by forklift - front side

1. Check the route of transport for the minimal height and width.
2. Check sufficient floor capacity on the route of transport. In case of doubt ask a stress analyst.
3. Check sufficient carrying capacity while using an elevator.
4. Position the forks between the bars of the box as shown in the figure. Make sure the side towards the operator is the one with the labels on it.

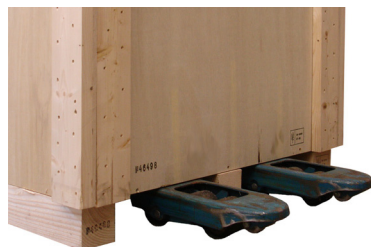
Figure 3.3: Transportation by forklift - rear side

5. Make sure the forks of the fork lift are longer than the box and projects out of the back of the box as shown in the figure.
6. Now lift the fork and move the box to the site.

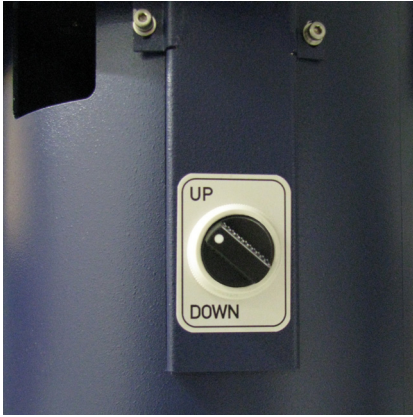
Figure 5.1: Start the Magnet Stand

Set the magnet stand into operation by switching the pneumatic controller to UP position.

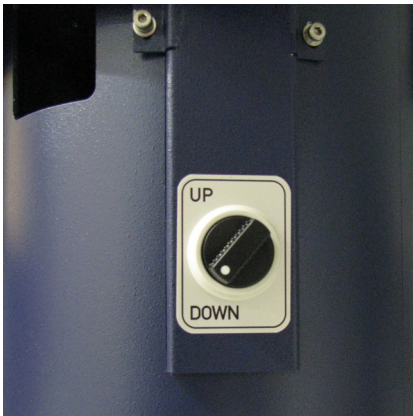
Figure 5.2: Stop the Magnet Stand

For any work at the magnet system like maintenance or refill of helium stop the magnet stand by switching the pneumatic controller to DOWN position.

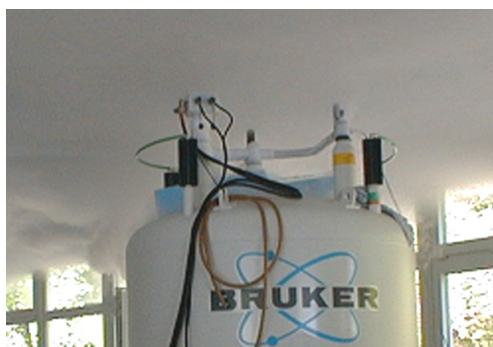
Figure 6.1: Quench picture

A quench is the very fast de-energizing of the magnet by loss of its superconductivity. The stored magnetic energy is converted into heat, which promotes rapid evaporation of large quantities of helium. After an appearance of a quench contact Bruker Service immediately.
